Annual Inspection

Creech St Michael Toddler Area

Inspection Ref: 1990888

Inspected: 2-March-2023 - 08:43 by Lyn Williams RPII Annual Inspector

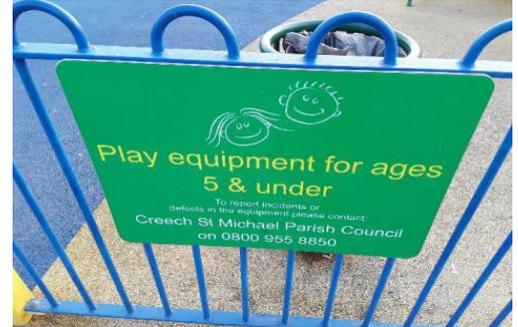
BS EN 1176 Part 7 recommends that signage shall include the site name / address - Provide additional information

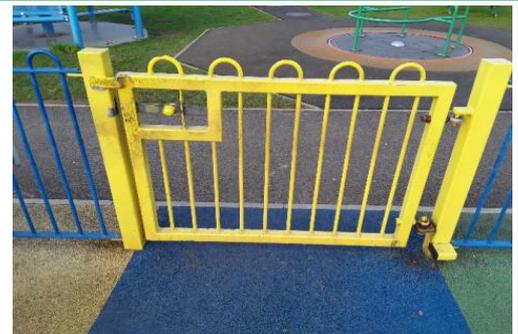
The paintwork on this item has been damaged or worn exposing the metal underneath which is rusting - Treat any rusting components and repaint

The rubber buffer is missing from the latch plate - Replace rubber buffer

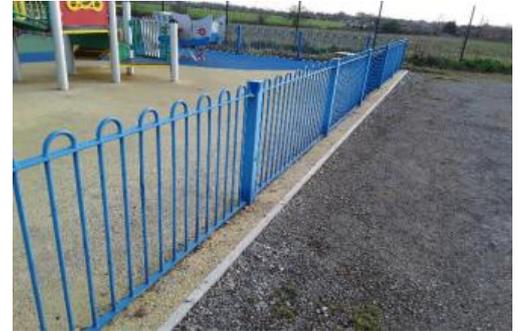
This item is satisfactory - no work required -

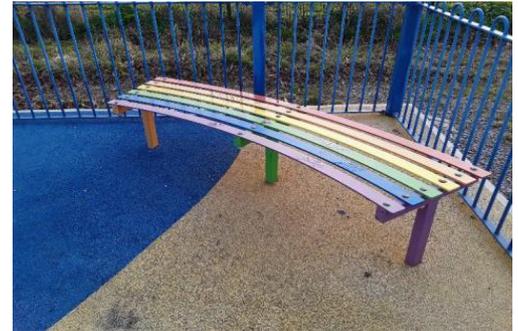
The item has exposed edges and corners with a radius of less than 3mm - Provide a 3mm radius to all exposed edges and corners

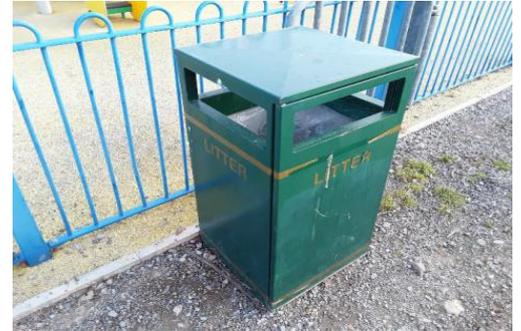
The bin is not securely fixed to the surface and there is some possibility of the item tipping or rolling over - Secure the bin to the ground

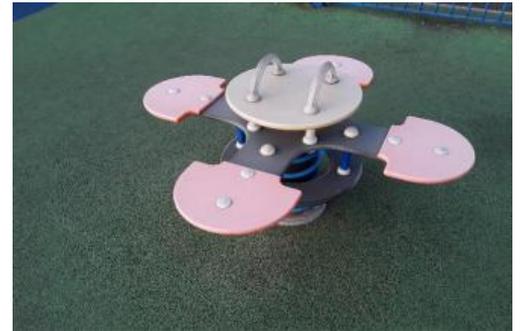
This item is satisfactory - no work required -

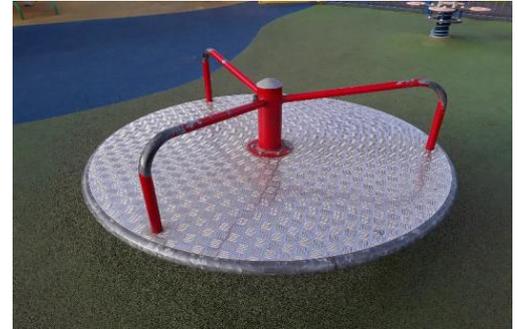
The paint is flaking off the metalwork - Rub down and re-paint

The height to the underside of the roundabout platform is less than 400mm and fails the requirements of BS EN 1176 Part 5 - Monitor - No remedial work recommended

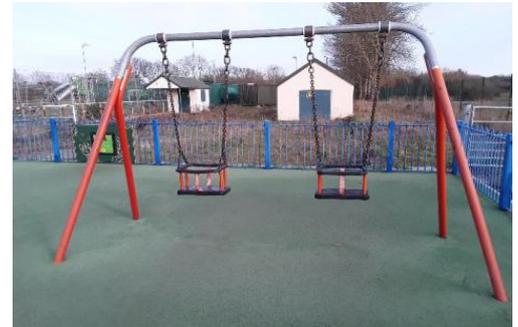
The chain openings are in excess of the 8.6mm as recommended by BS EN 1176 - Monitor - No remedial work recommended

There is some notable evidence of chain wear - Monitor for any further deterioration and replace when 40% worn

There is surface corrosion present on the item - Consider treating the item

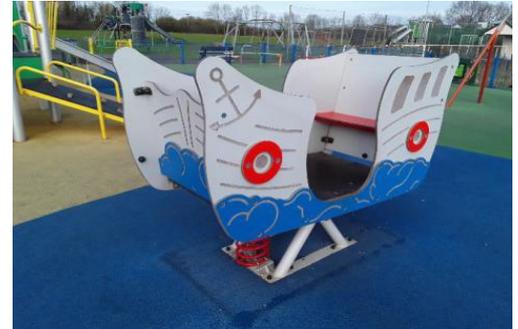
There is surface corrosion present on the item - Consider treating the item

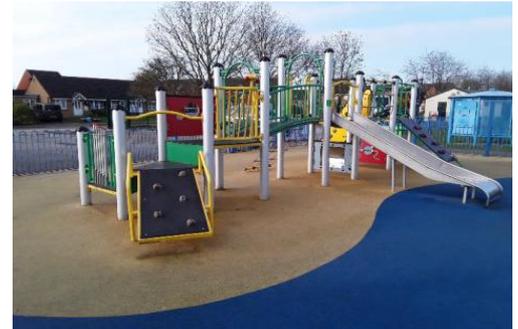
There is/are bolt cap covers missing or damaged on the item - Replace missing or damaged bolt cap covers

The rope anchor bar forms a hard object within the falling space of the equipment in contravention of the requirements of BS EN 1176 Part 1 - Monitor - No remedial work recommended

The ropes/nets are worn/damaged in places - Monitor for any further deterioration and repair or replace as required

The ladder section is slightly loose in its foundations - Monitor for any further deterioration and repair as required

There are splits in the timber running through fixing points and creating some instability in the structure - Replace all affected timber parts

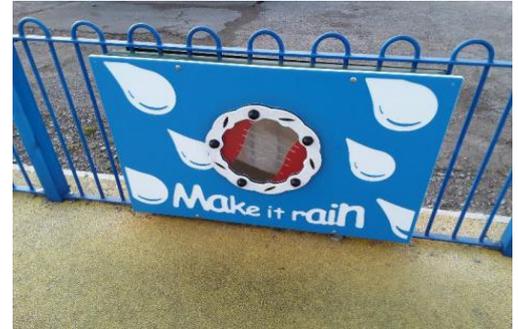
There are redundant bolt holes in the play panel - Monitor and provide inserts if required

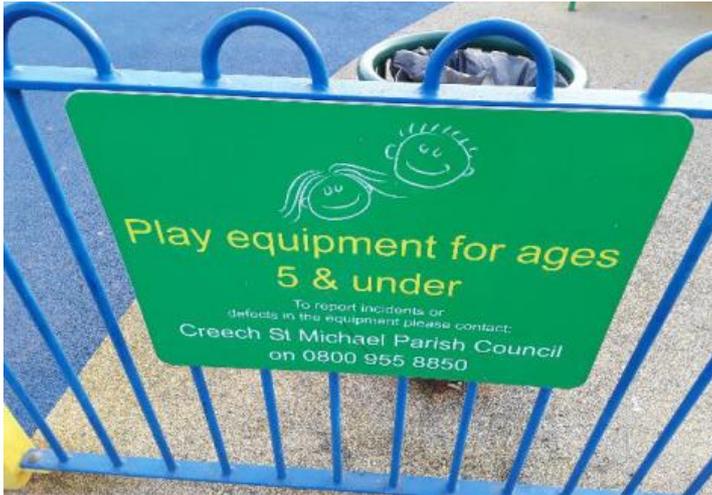
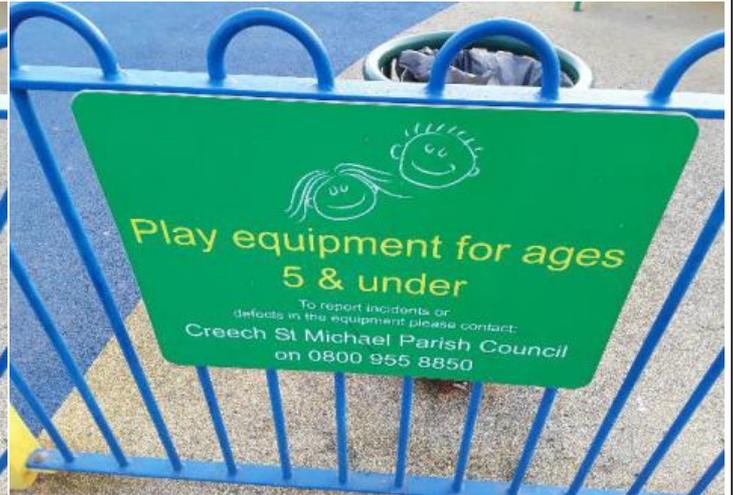
Finding: BS EN 1176 Part 7 recommends that signage shall include the site name / address
Action: Provide additional information

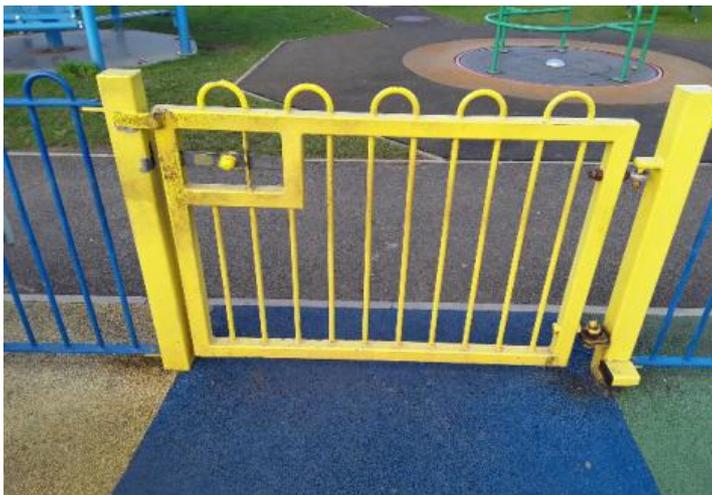
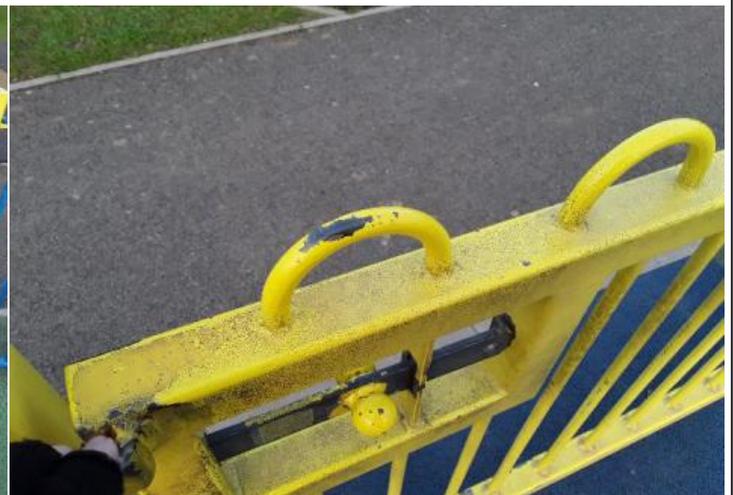
Finding: The paintwork on this item has been damaged or worn exposing the metal underneath which is rusting
Action: Treat any rusting components and repaint

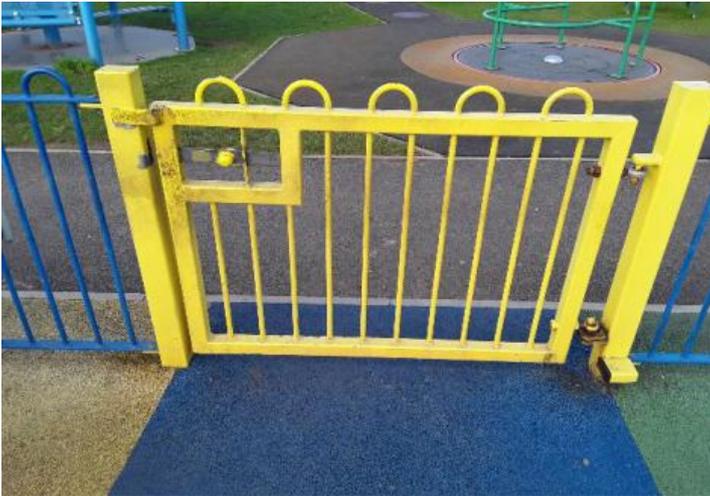
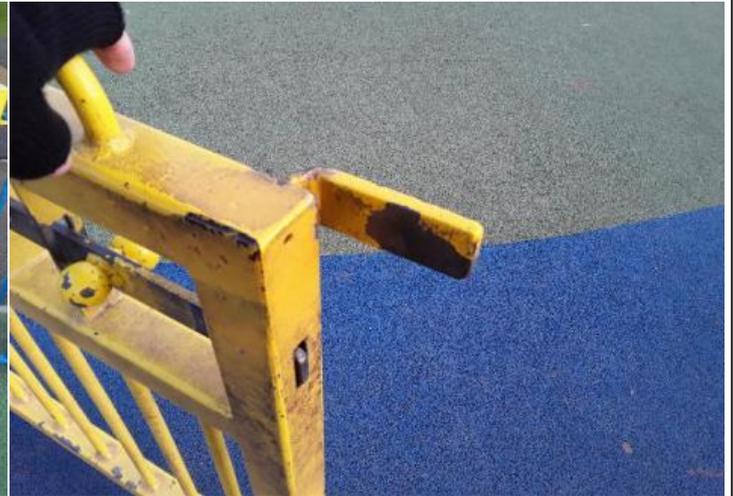
Finding: The rubber buffer is missing from the latch plate

Action: Replace rubber buffer

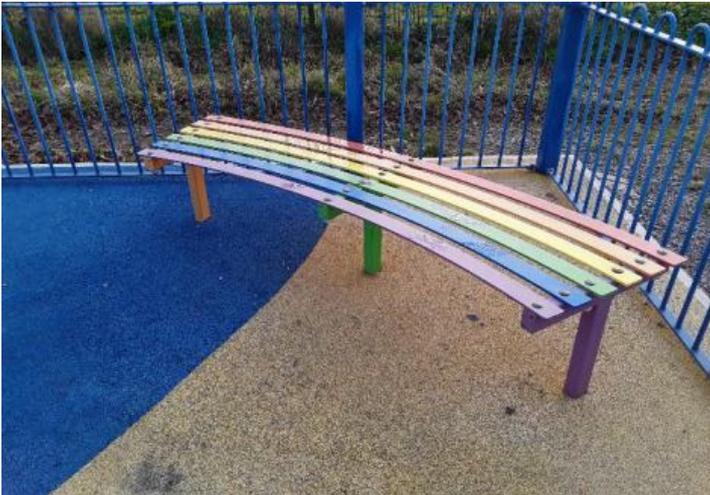
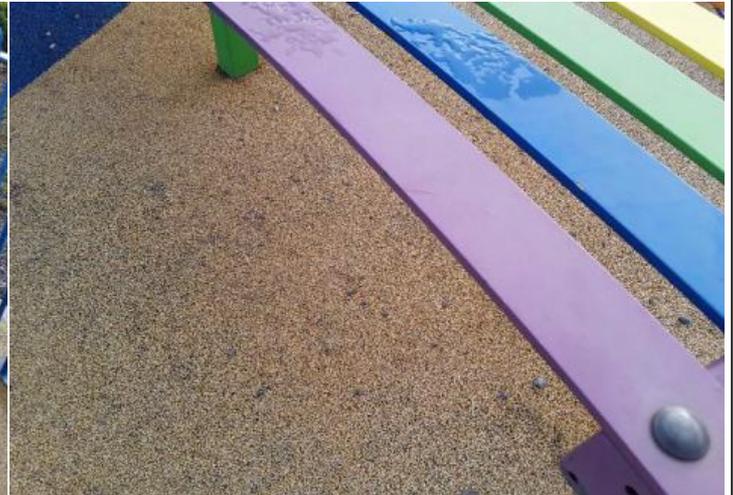
Finding: The item has exposed edges and corners with a radius of less than 3mm

Action: Provide a 3mm radius to all exposed edges and corners

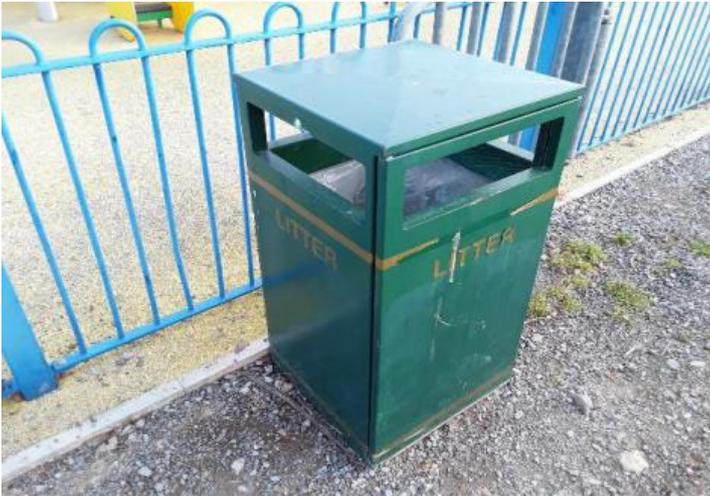
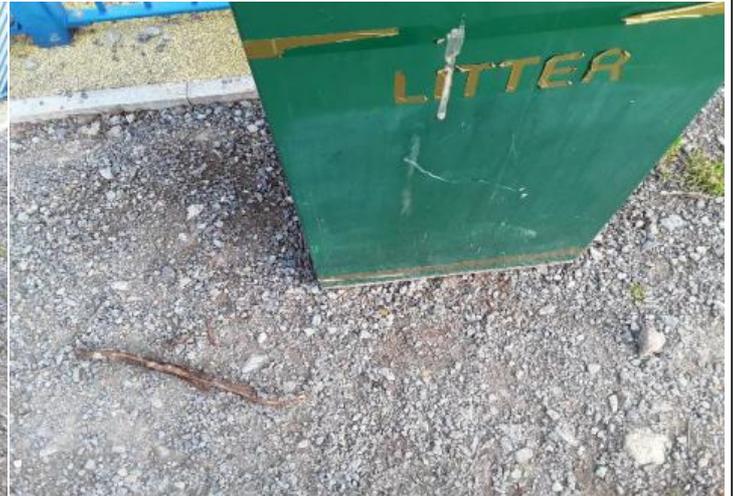
Finding: The bin is not securely fixed to the surface and there is some possibility of the item tipping or rolling over

Action: Secure the bin to the ground

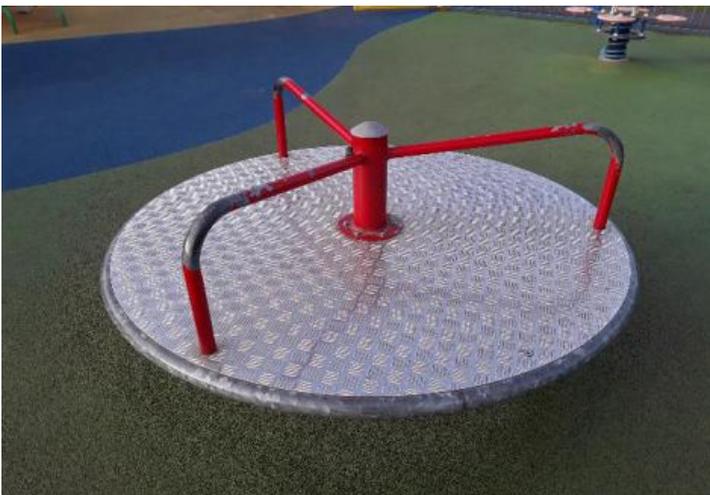
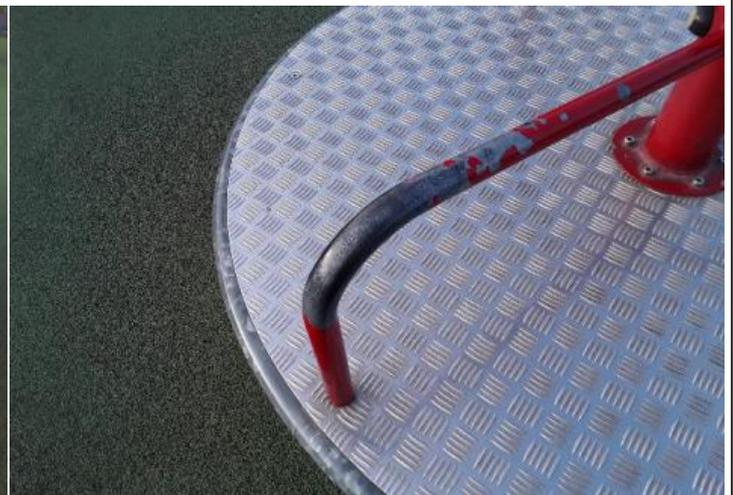
Finding: The paint is flaking off the metalwork

Action: Rub down and re-paint

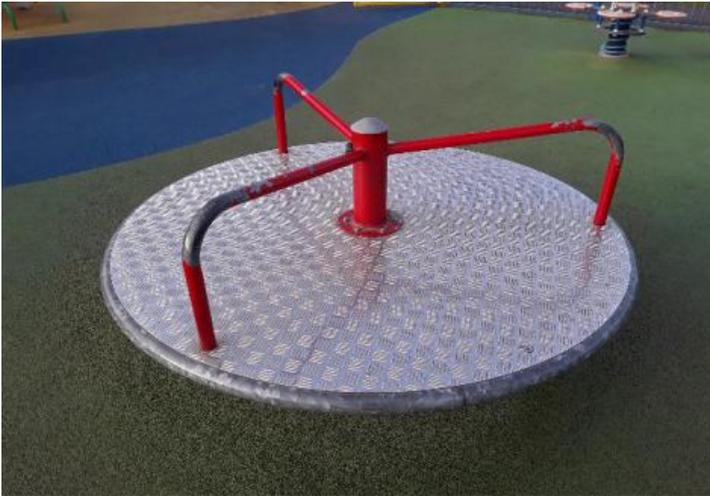
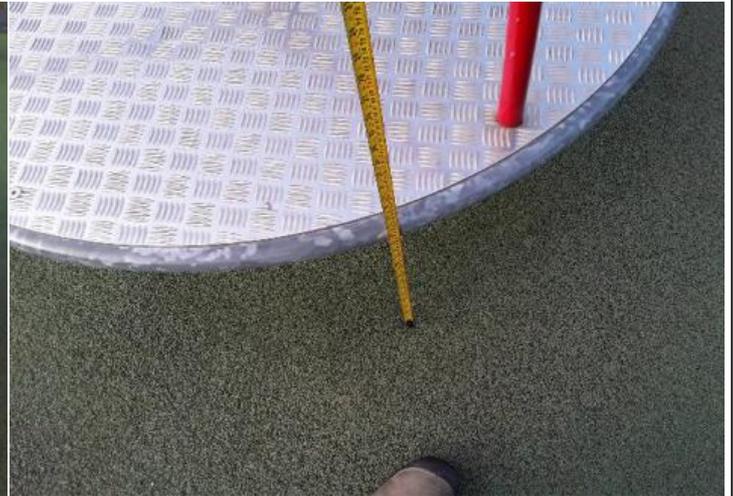
Finding: The height to the underside of the roundabout platform is less than 400mm and fails the requirements of BS EN 1176 Part 5

Action: Monitor - No remedial work recommended

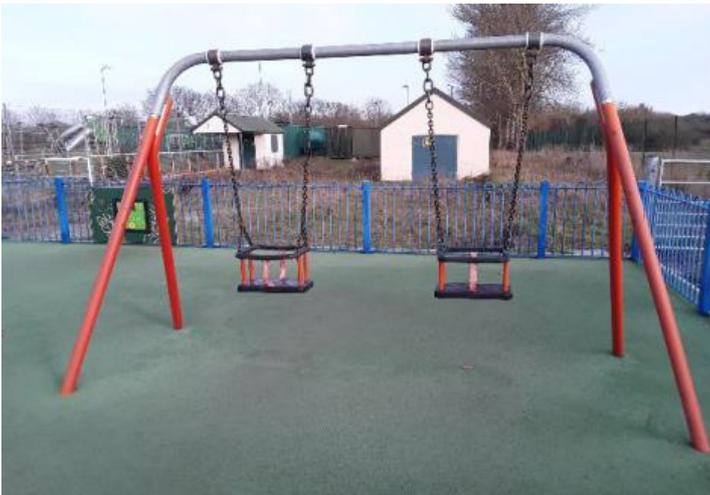
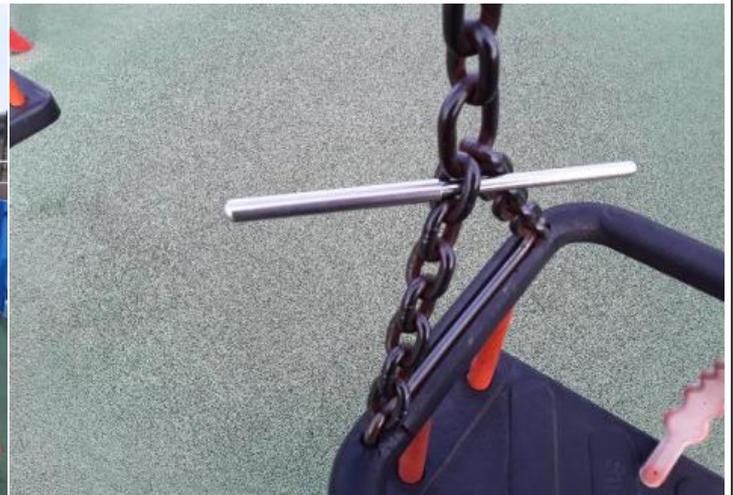
Finding: The chain openings are in excess of the 8.6mm as recommended by BS EN 1176

Action: Monitor - No remedial work recommended

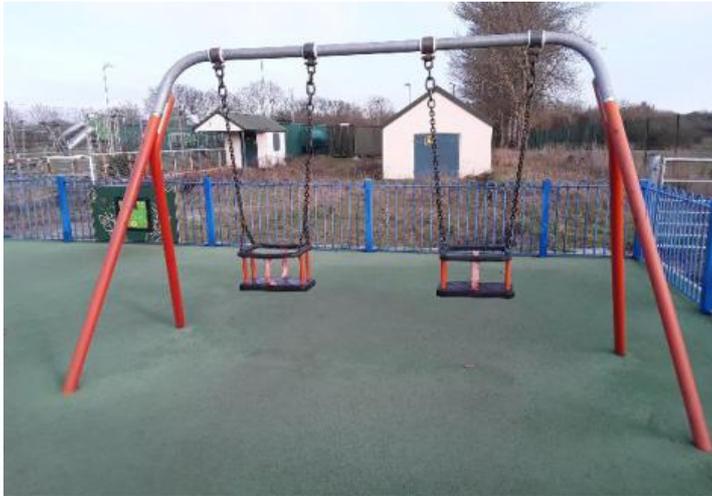
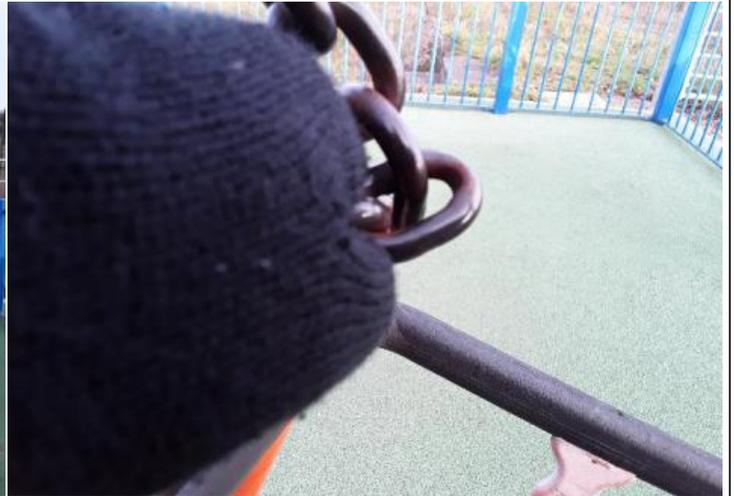
Finding: There is some notable evidence of chain wear

Action: Monitor for any further deterioration and replace when 40% worn

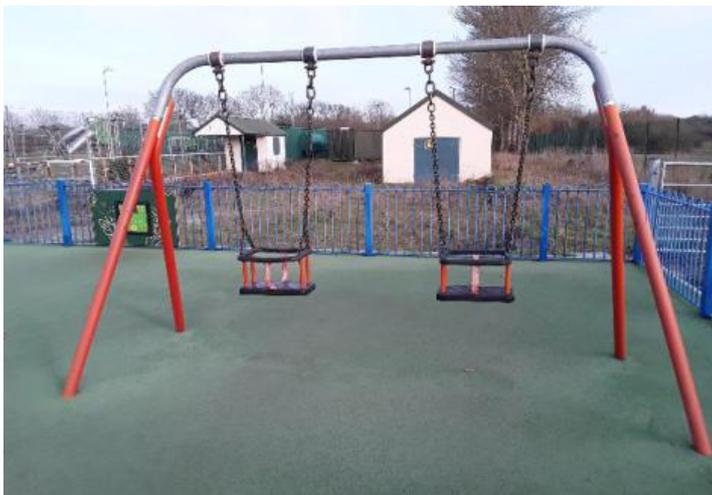
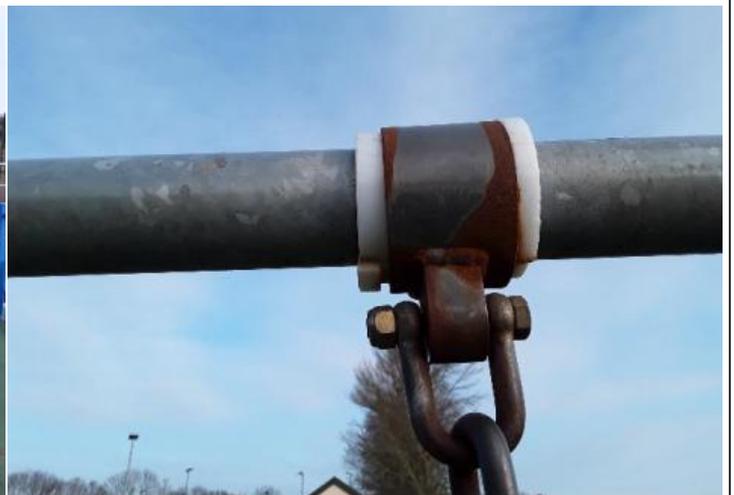
Finding: There is surface corrosion present on the item

Action: Consider treating the item

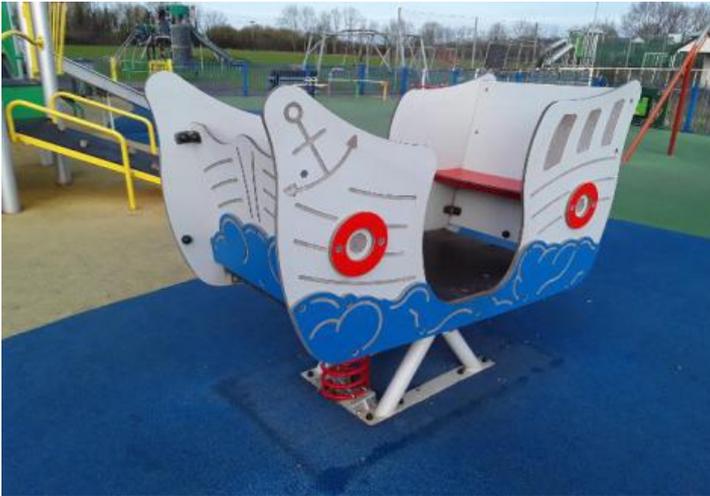
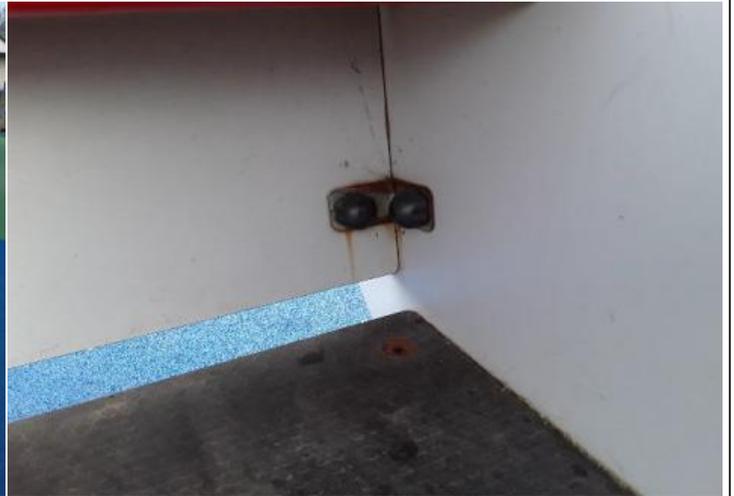
Finding: There is surface corrosion present on the item

Action: Consider treating the item

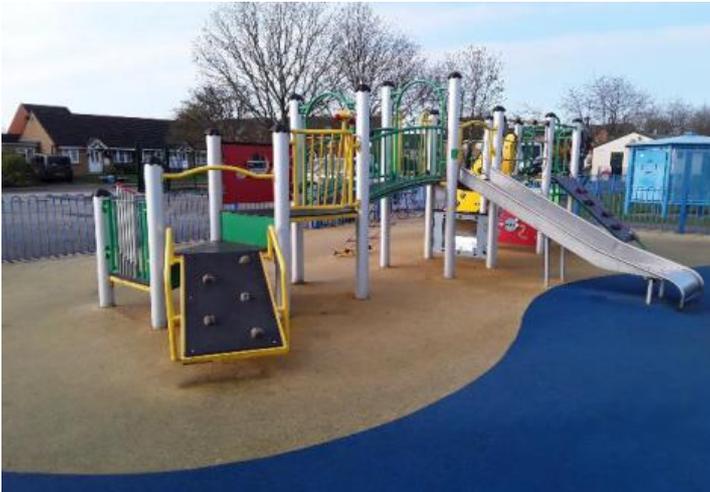
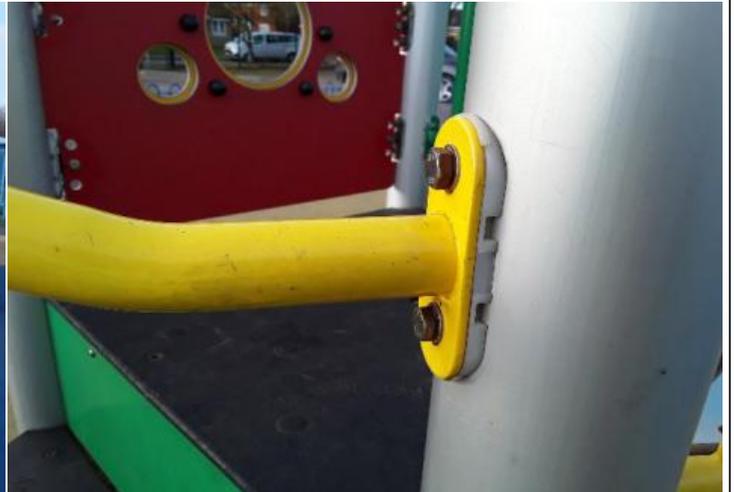
Finding: There is/are bolt cap covers missing or damaged on the item

Action: Replace missing or damaged bolt cap covers

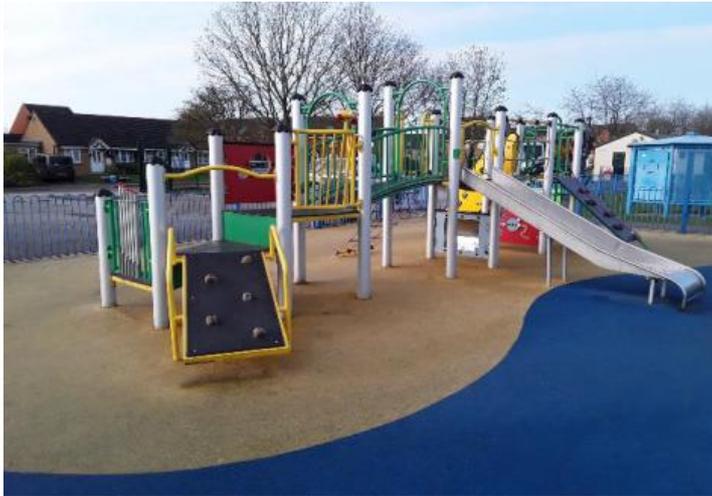
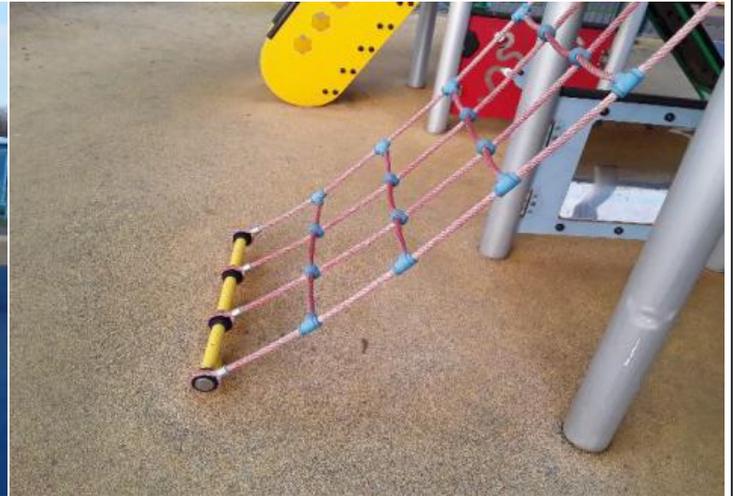
Finding: The rope anchor bar forms a hard object within the falling space of the equipment in contravention of the requirements of BS EN 1176 Part 1
Action: Monitor - No remedial work recommended

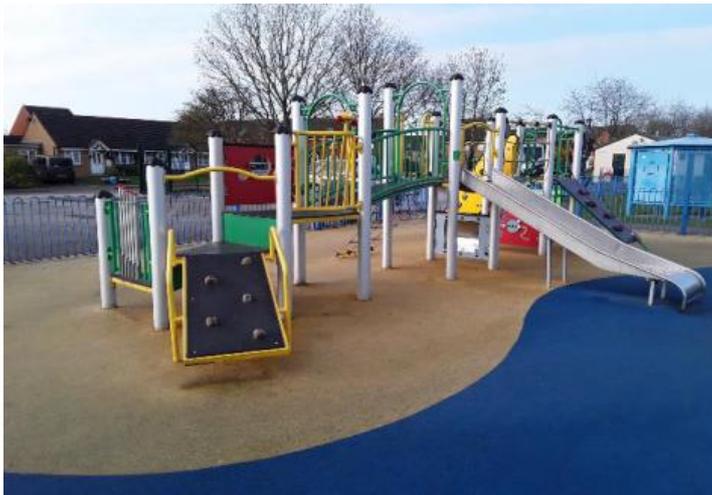
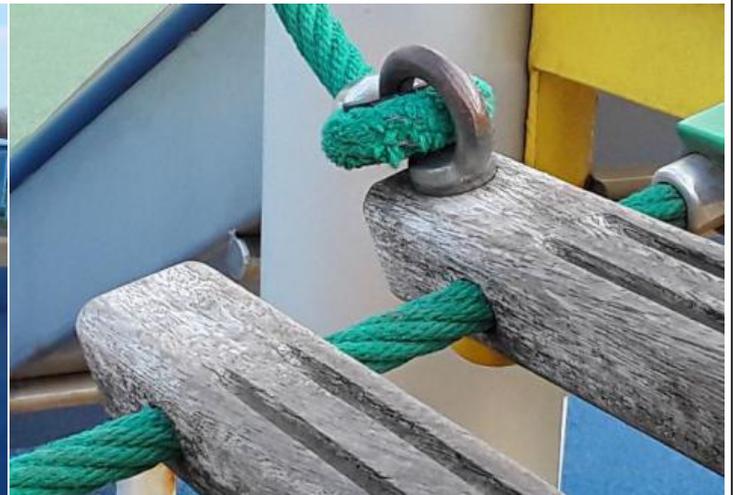
Finding: The ropes/nets are worn/damaged in places
Action: Monitor for any further deterioration and repair or replace as required

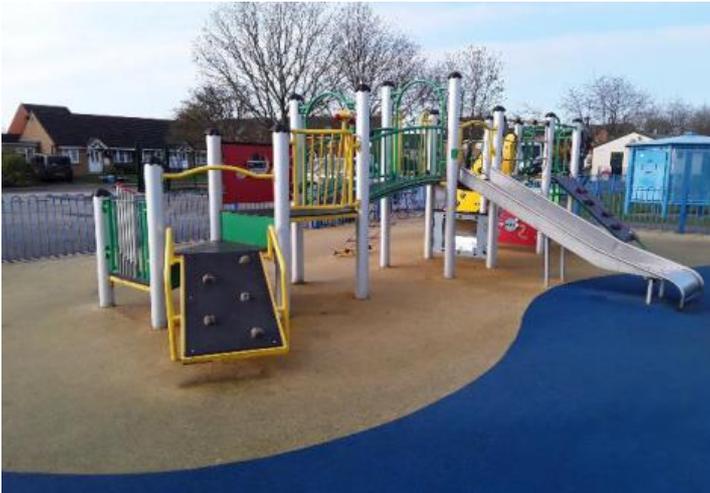
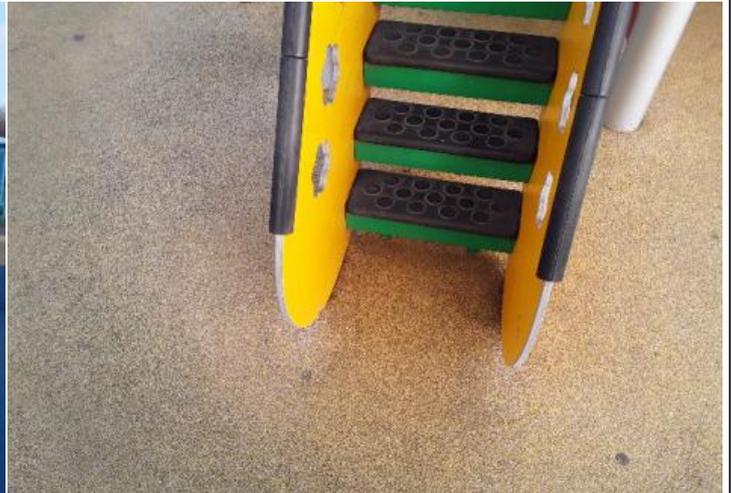
Finding: The ladder section is slightly loose in its foundations

Action: Monitor for any further deterioration and repair as required

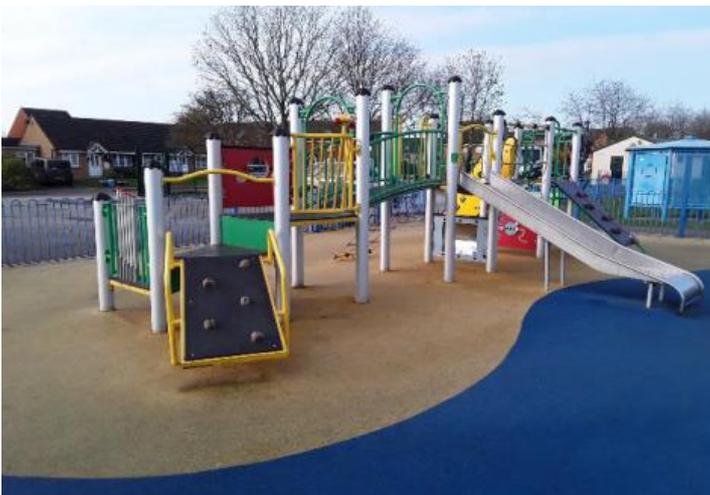
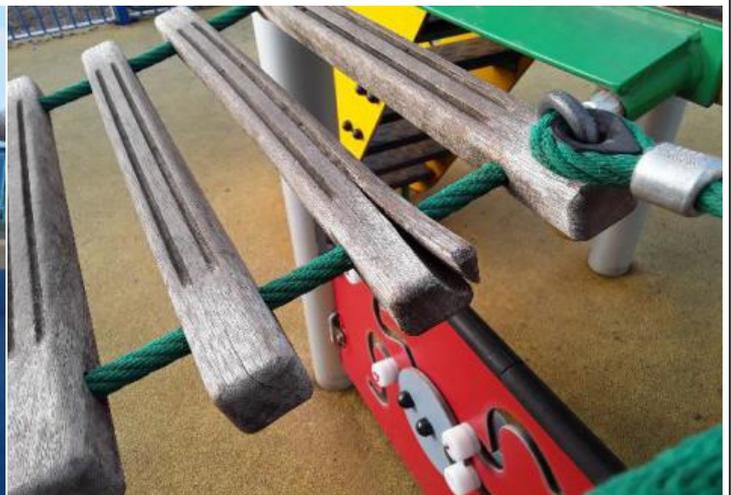
Finding: There are splits in the timber running through fixing points and creating some instability in the structure

Action: Replace all affected timber parts

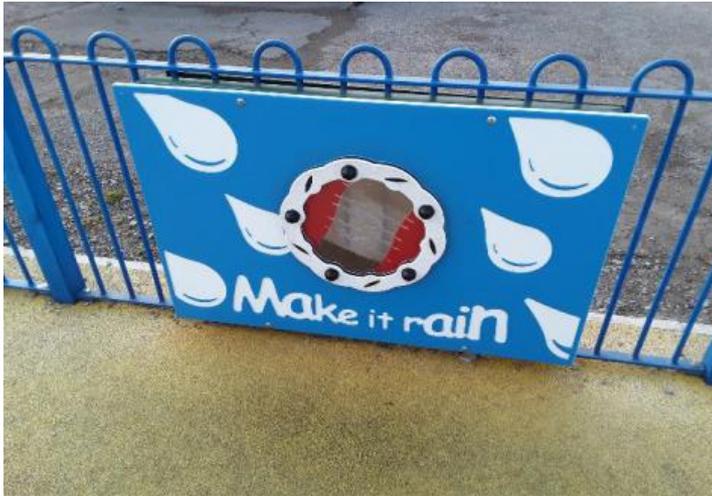
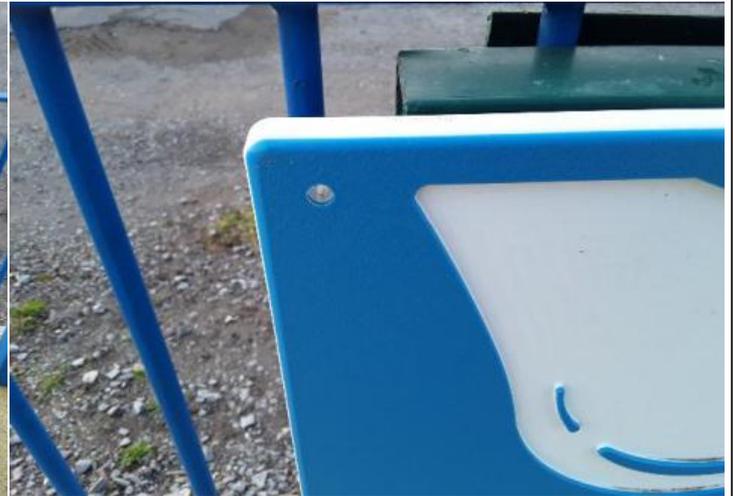
Finding: There are redundant bolt holes in the play panel

Action: Monitor and provide inserts if required
