Annual Inspection

Creech St Michael Toddler Area

Inspection Ref: 1990888

Inspected: 2-March-2023 - 08:43 by Lyn Williams RPII Annual Inspector

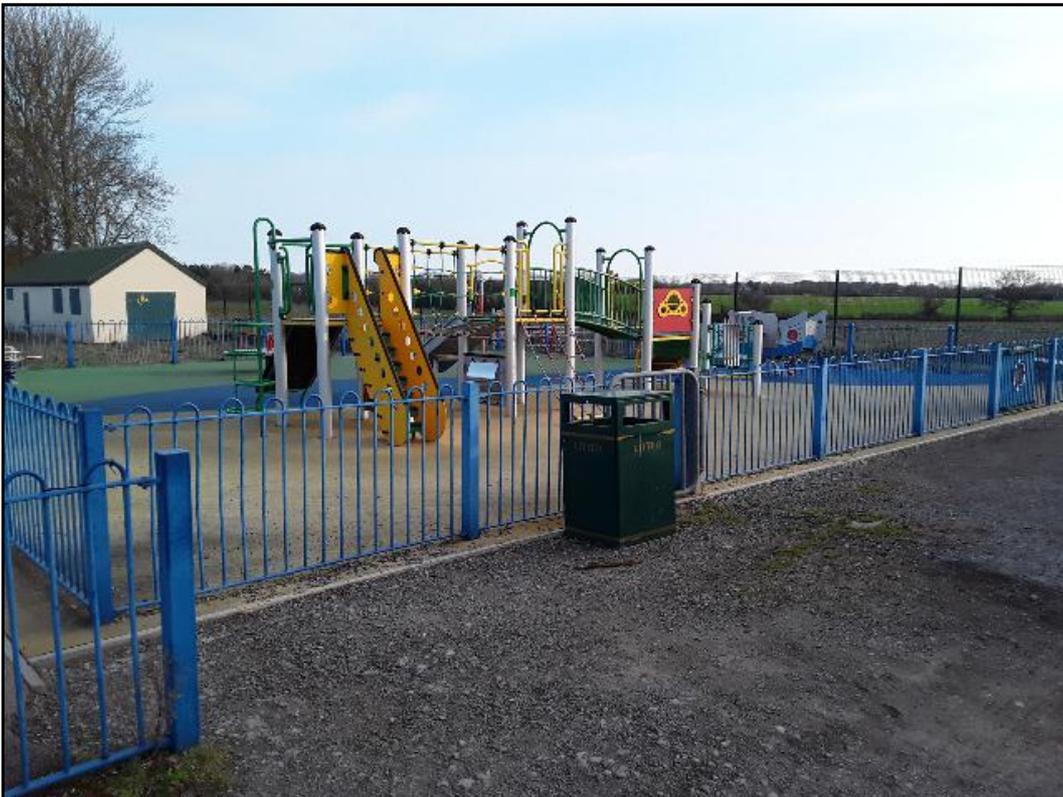
Location:

The site is partially overlooked by properties in the local community

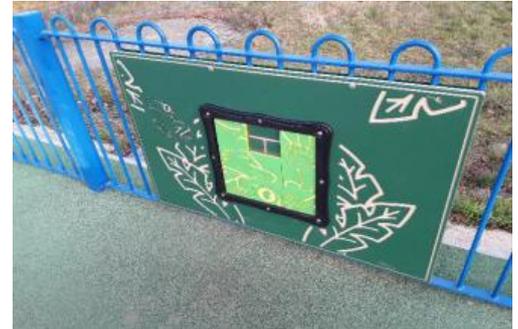
i 4 - Very Low Risk

Item: Play Panel
Manufacturer: Not Identified
Surface Type: N/A
Item Quantity: 1
Equipment Compliance: Yes
Surface Area Compliance: N/A

Total Findings: 1

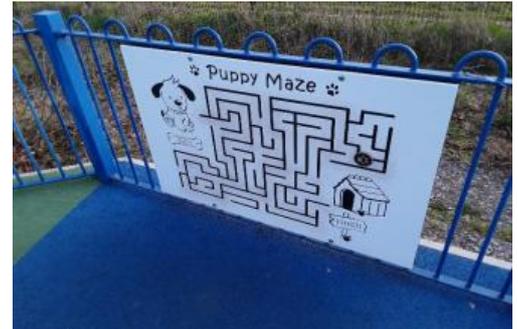
i 4 - Very Low Risk

Item: Play Panel
Manufacturer: Not Identified
Surface Type: N/A
Item Quantity: 1
Equipment Compliance: Yes
Surface Area Compliance: N/A

Total Findings: 1

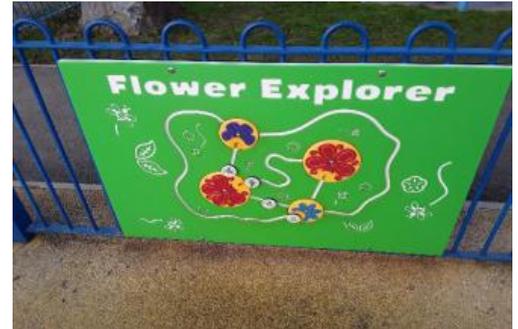
i 4 - Very Low Risk

Item: Play Panel
Manufacturer: Not Identified
Surface Type: N/A
Item Quantity: 1
Equipment Compliance: Yes
Surface Area Compliance: N/A

Total Findings: 1
